(6) PHASE I INSPECTION REPORT
NATIONAL DAM SAFETY PROGRAM.

City of Utica Reservoir 5 (Inventory Number NY 199)
Mohawk River Basin, Oneida County, New York.
Phase I Inspection Report

Name of Dam City of Utica Reservoir 5 NY199
State Located New York
County Located Oneida
Stream Not Applicable
Date of Inspection July 23, 1980

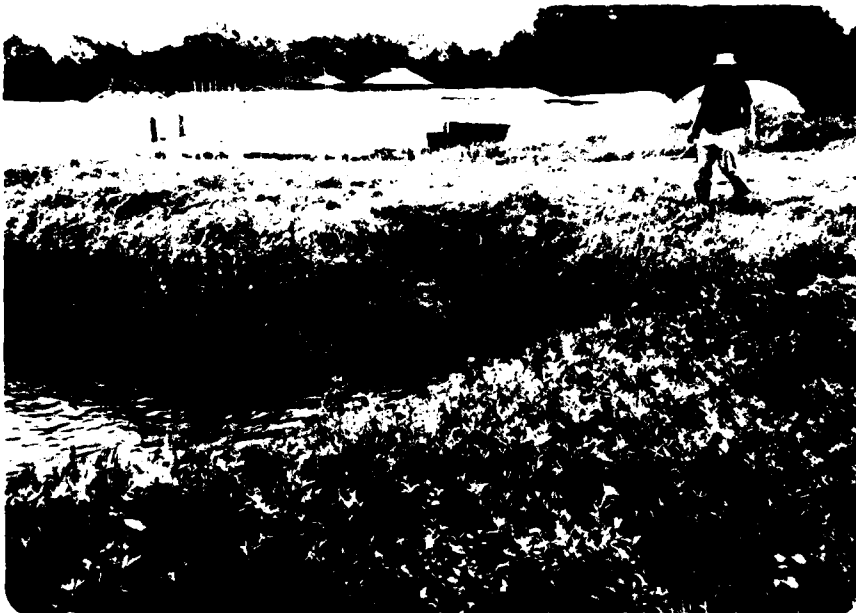
3. Outlet of Reservoir #5.

The outlet of the impoundment consists of a 20 inch diameter clay pipe. This pipe is in operating condition at the present time.
